TOWN OF ROSS

FACILITIES MASTER PLAN

FINAL
June 15, 2023

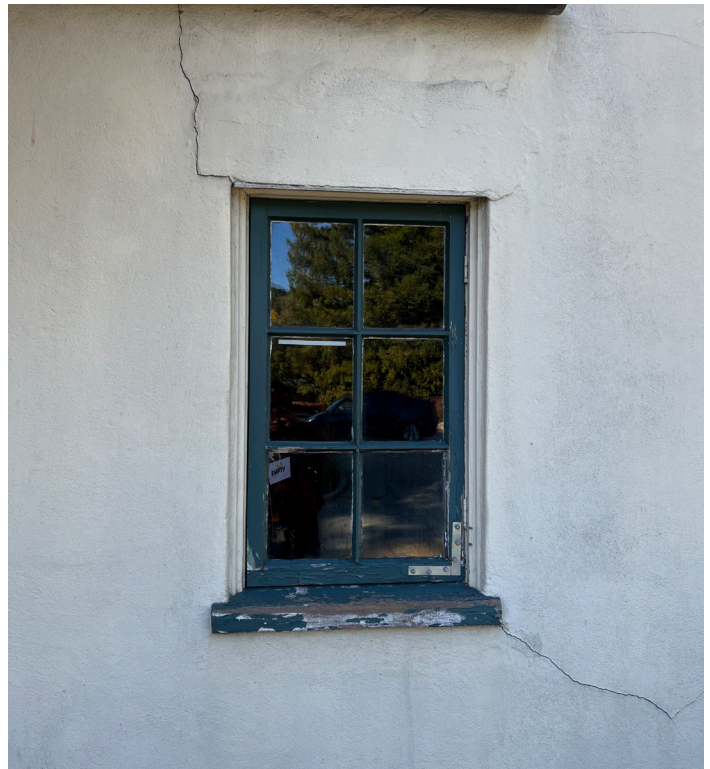
Public Safety Building - Deteriorated Exterior Enveloped

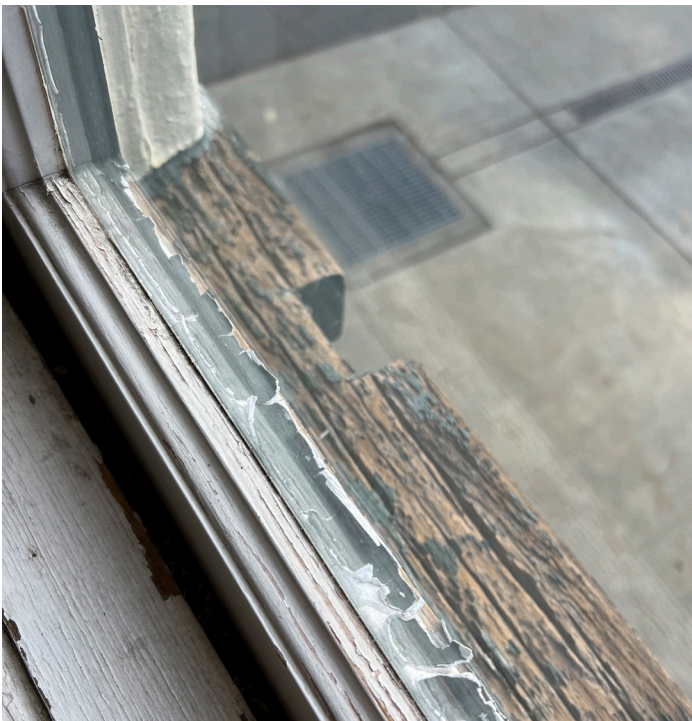
Public Safety Building - Deteriorated Window

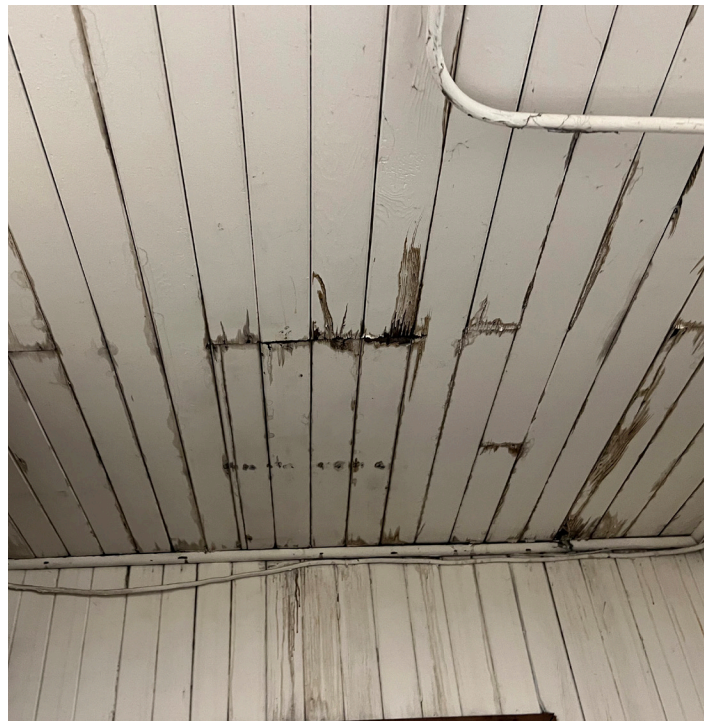
Police Department – Deteriorated Ceiling/Wall

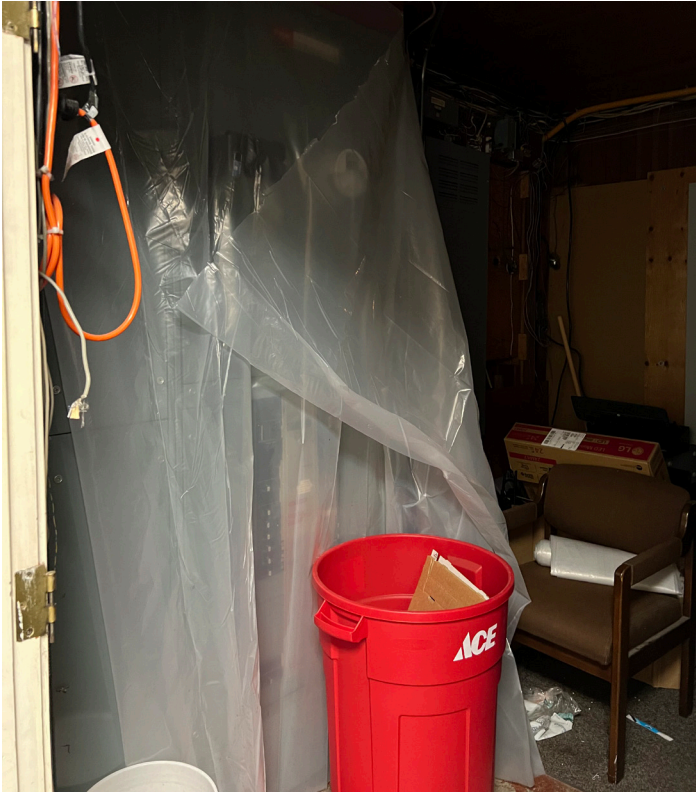
Switchboard Protected from Water - Police Station
