APPENDIX G-1

GEOTECHNICAL FEASIBILITY EVALUATION, JULY 2012

RE: Geotechnical Feasibility Evaluation
Upper Road Land Division - Vesting Tentative Map
Assessor's Parcel 073-011-26
Ross, California

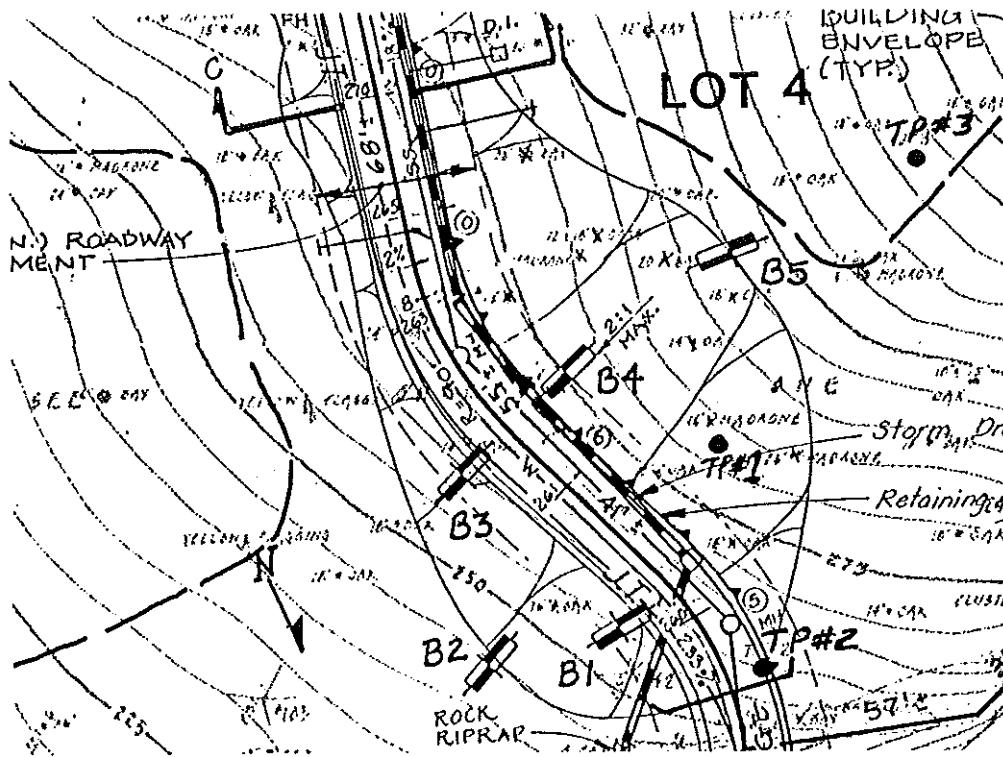
AREA 1

Area 1: Test pits B1 and B2 encountered weak sheared shale and greenstone down to a depth of 12 feet. Seepage was encountered at a depth of 10 feet. These conditions are similar to those encountered in Test Pit 1 of our 1989 investigation where a weak greenstone rock and seepage were evident at 13 feet. The depth of excavation for the fills and cut slopes within the area of Test Pit 1 and Test Pits B1 and B2 will be approximately 12 to 14 feet.
