TOWN OF ROSS

FACILITIES MASTER PLAN

FINAL
June 15, 2023

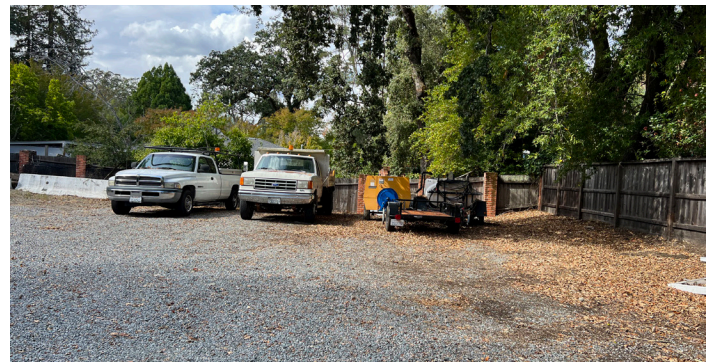
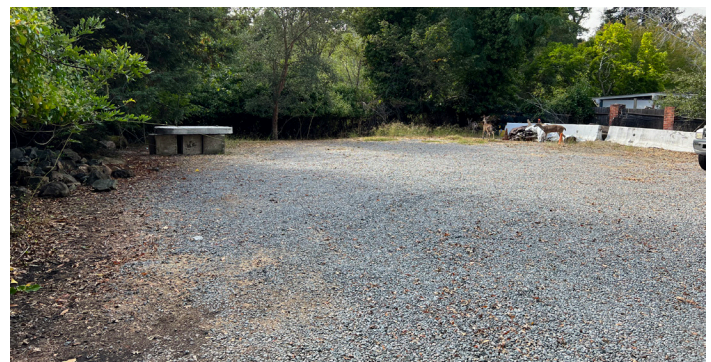
- Yard contains ample space for laydown and staging of materials
- Yard requires relocation for future housing needs
