**Agenda Item No. 15.**

**Staff Report**

**Subject:** Three Bear Hut and Natalie Coffin-Greene Park rehabilitation project status report and presentation by Consultant Garavaglia Inc.

# ATTACHMENT 2

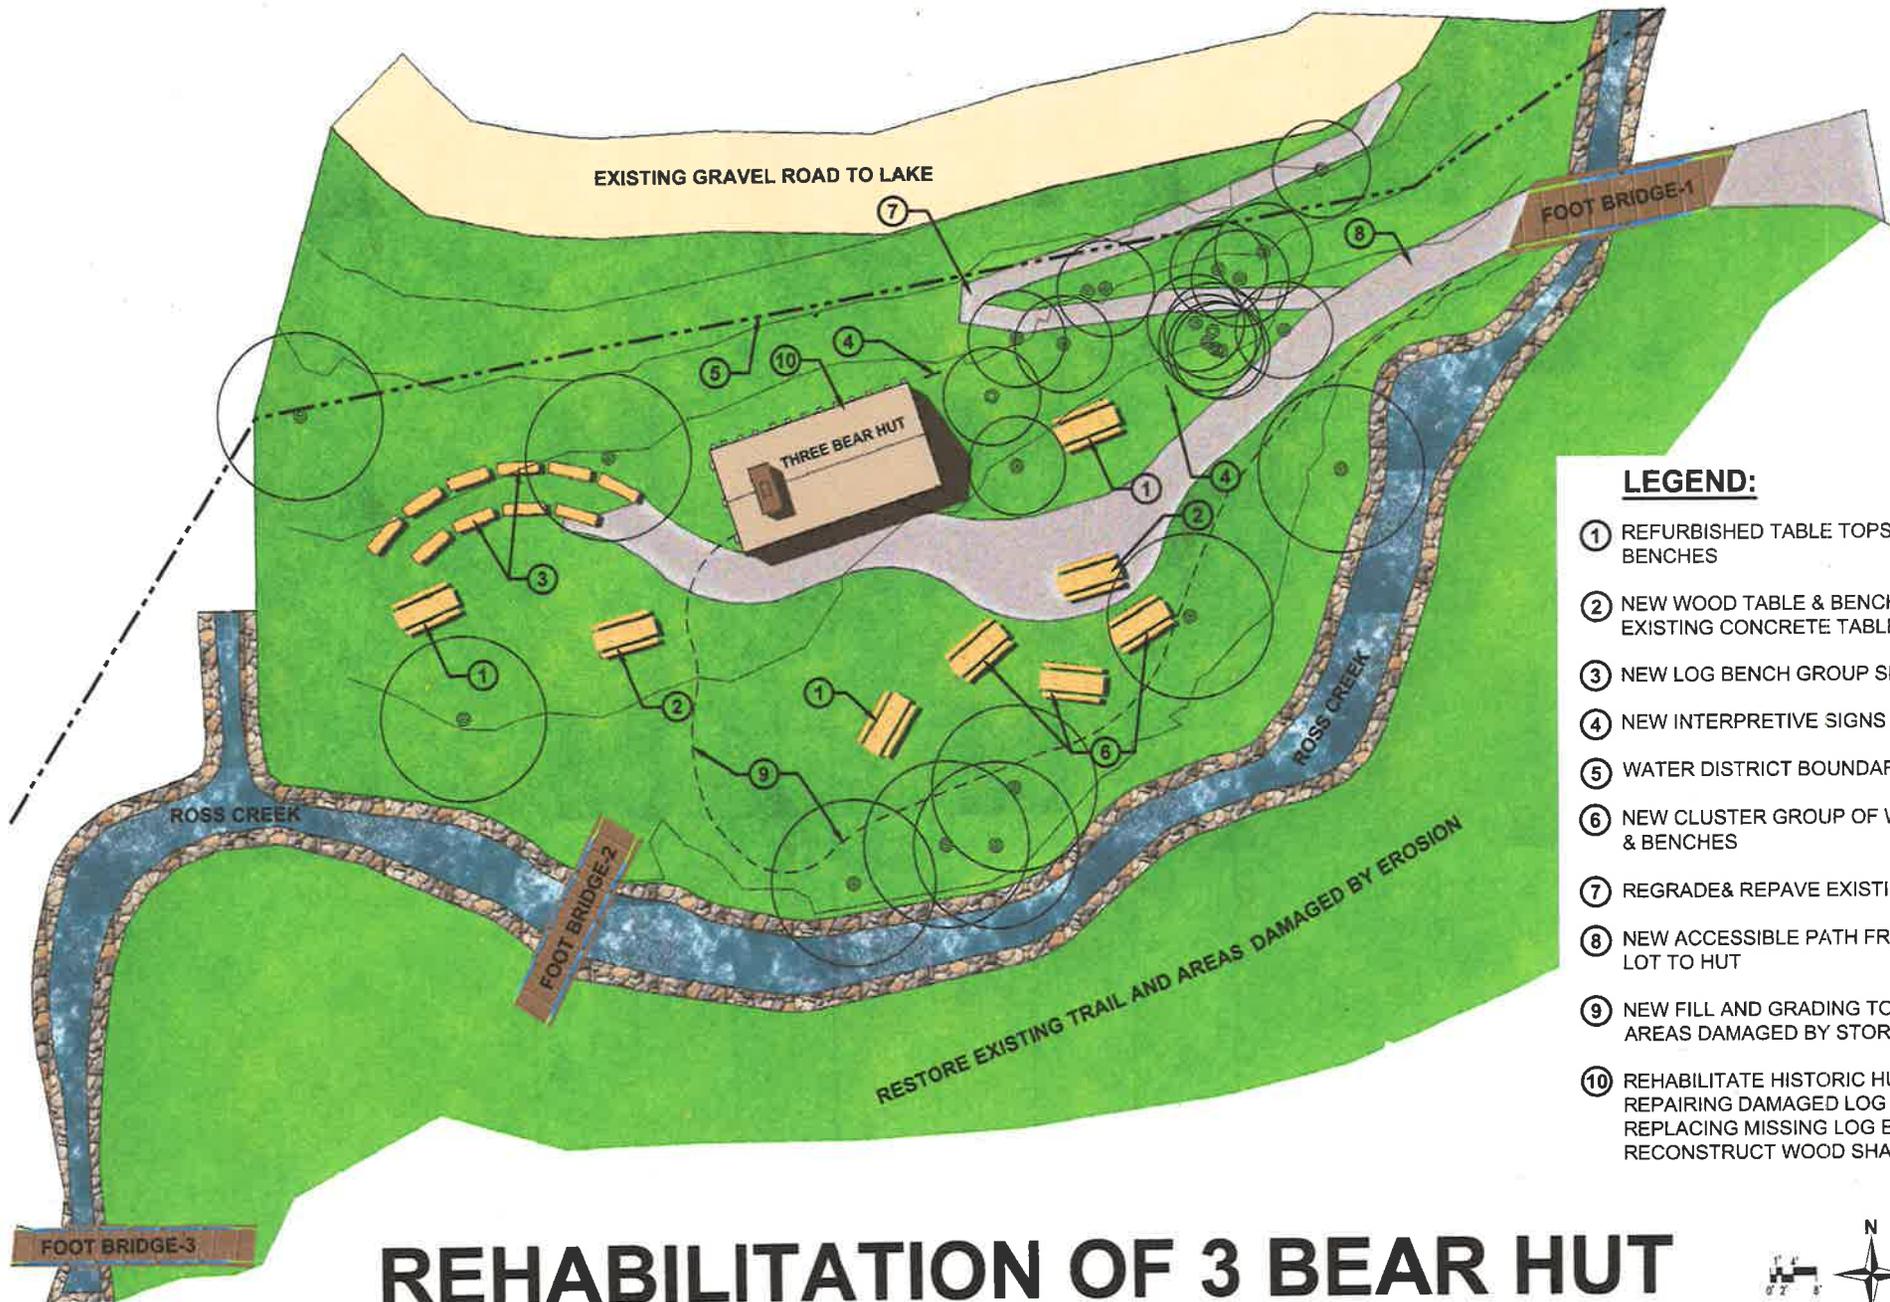
# ATTACHMENT 1

- ① REFURBISHED TABLE TOPS & NEW BENCHES
- ② NEW WOOD TABLE & BENCH IN PLACE OF EXISTING CONCRETE TABLE & BENCH
- ③ NEW LOG BENCH GROUP SEATING
- ④ NEW INTERPRETIVE SIGNS
- ⑤ WATER DISTRICT BOUNDARY
- ⑥ NEW CLUSTER GROUP OF WOOD TABLES & BENCHES
- ⑦ REGRADE & REPAVE EXISTING PATH
- ⑧ NEW ACCESSIBLE PATH FROM PARKING LOT TO HUT
- ⑨ NEW FILL AND GRADING TO RESTORE AREAS DAMAGED BY STORMS
- ⑩ REHABILITATE HISTORIC HUT BY REPAIRING DAMAGED LOG ELEMENTS, REPLACING MISSING LOG ELEMENTS, AND RECONSTRUCT WOOD SHAKE ROOF
