TOWN OF ROSS

FACILITIES MASTER PLAN

FINAL
June 15, 2023

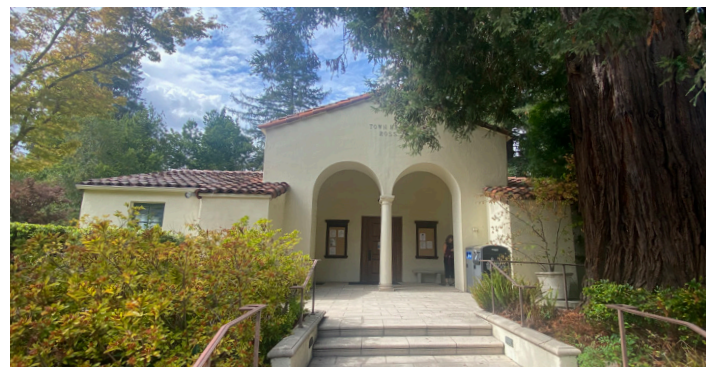
Town Hall - Exterior

F.	Roof Drainage		3				
	G.	Gutters / Downspouts			2			
	H.	Roof Vents		3				
N O T E S	2.1 - Exterior wall finish is in fair condition but contains minimal surface cracking and grime buildup. Some sealants around building exterior are showing age.

2.3 A - Windows are in fair condition. No cracked glazing present but some deterioration around frames and window sills is visible.							
	2.3 B - Louvers are generally in good condition without damage visible. Vents for basement area at lower portion of exterior walls at sides of building contain damaged screening.

2.4 A - Roof surface is in poor condition with roof tiles cracked and out of plumb throughout. Some sealants at roof tiles are deteriorating. Tiles contain grime buildup and tree debris.

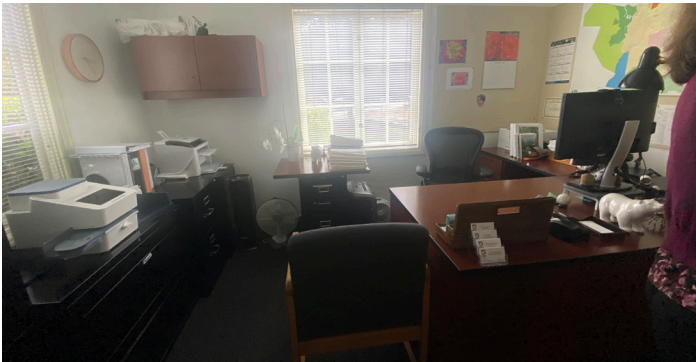
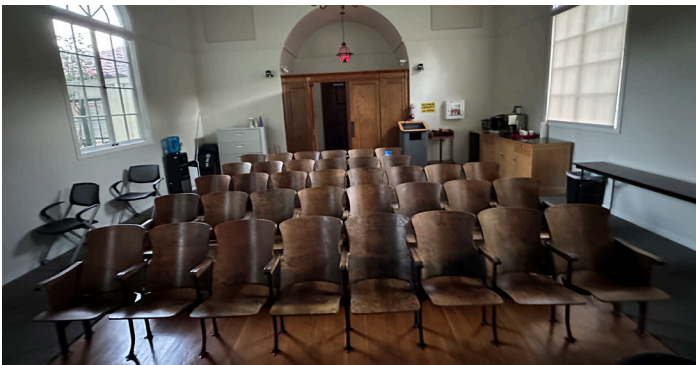
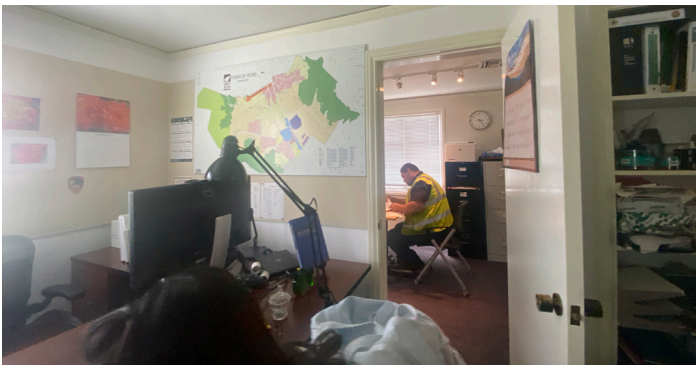
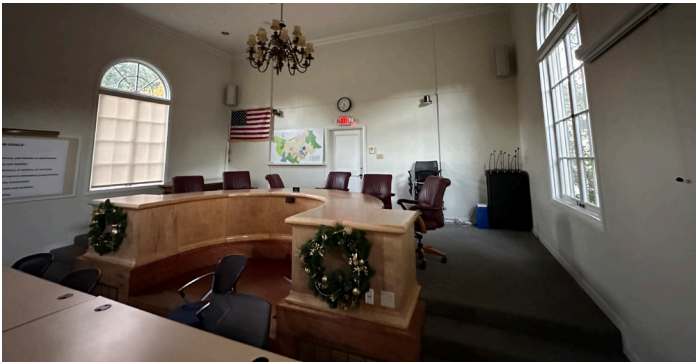
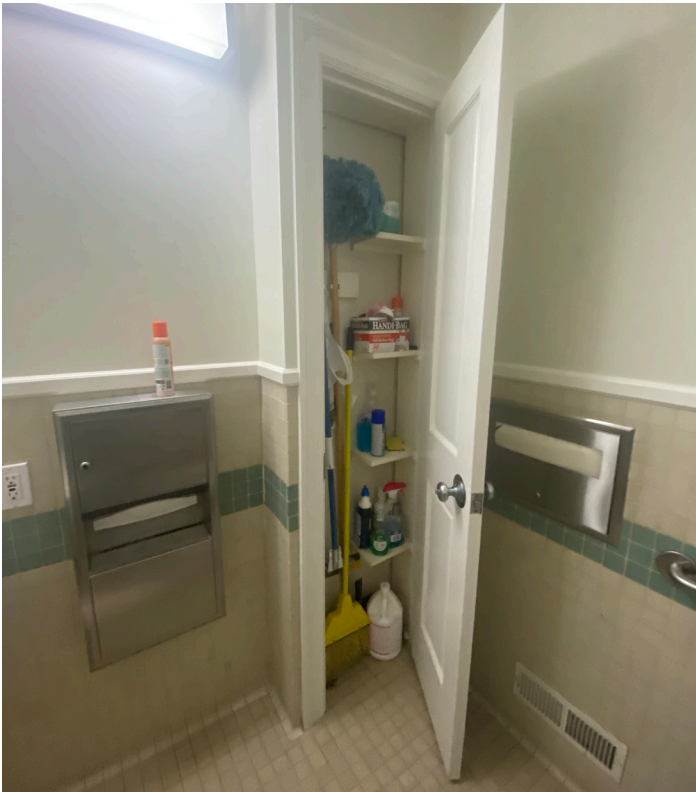
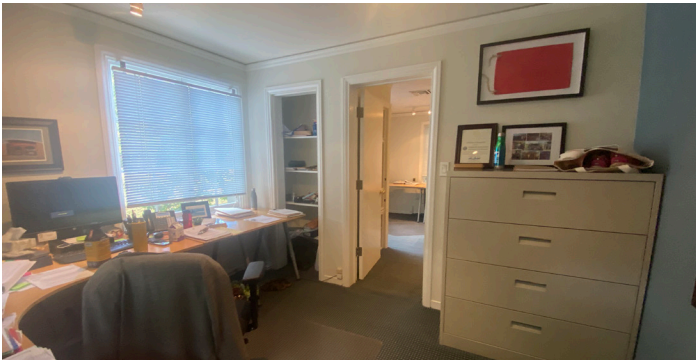
F.	Counter					N/A	
	G.	Shower Compartments					N/A	
4.8	Hazmat						2	
4.9	Room Capacity						3	
N O T E S	4.1 C - Plaster ceiling is in good condition overall at council chambers portion. At office areas, ceiling is in fair to good condition. Crown molding at office areas does not match molding at main portion of Town Hall and has yellowed considerably.

4.2 A - Carpeting at council chambers is stained and worn especially in areas of high foot traffic. Carpet at rear chambers office is similiary worn and does not match carpeting at remainder. At office areas, carpeting contains staining and visible deterioration in the weave.

4.2 D - Wood flooring at main seating area is considerably worn with wood finish deteriorated in many locations.							
	4.3 - Interior wall finishes at council chambers office at rear of building are in fair condition with exposed electrical wiring and no major staining. Walls at council chambers are in good condition as is wall finish at office areas.

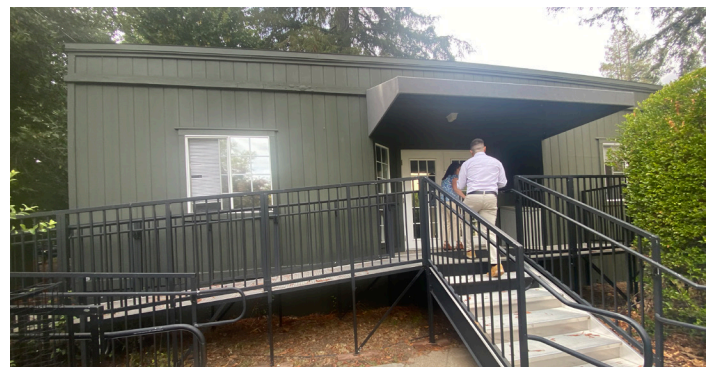
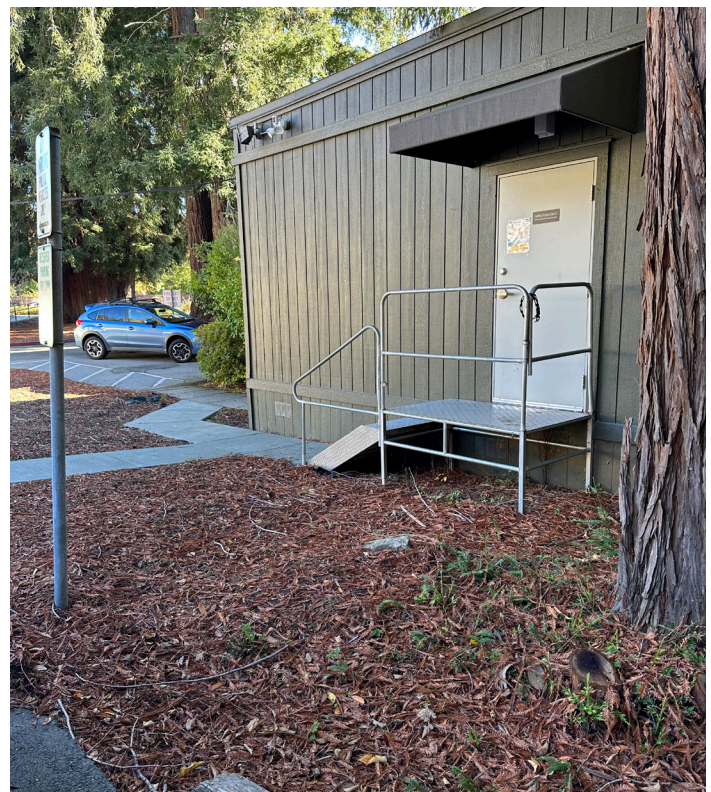
- Modular building construction doesn't allow for longevity of this facility on site
- New Lagunitas Road entry drive requires demolition of Planning & Building modular and relocation of staff before site changes commence
- Building is not easily located by the public as it is behind other buildings and not visible from Sir Francis Drake Blvd or Lagunitas Road
- Parking for facility is not intuitive and members of the public find the lot confusing to navigate
- Building is not connected to other civic center departments
- Mechanical system has provided comfort issues to those housed in building due to not operating 100% correctly
- Front counter, while in use, creates disruptions due to open location and close proximity to staff workstations

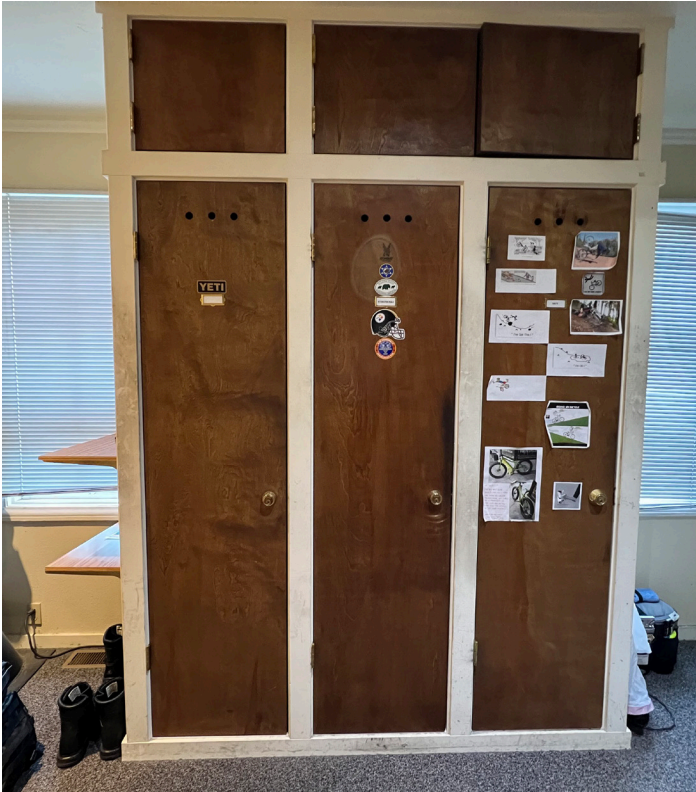
Police Station - Current Locker Configuration

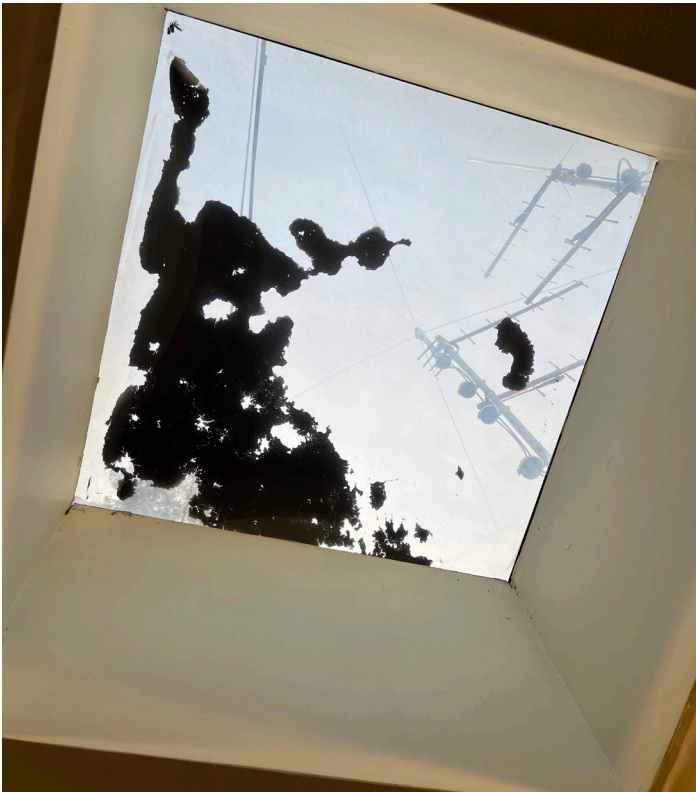
Police Station - Skylights

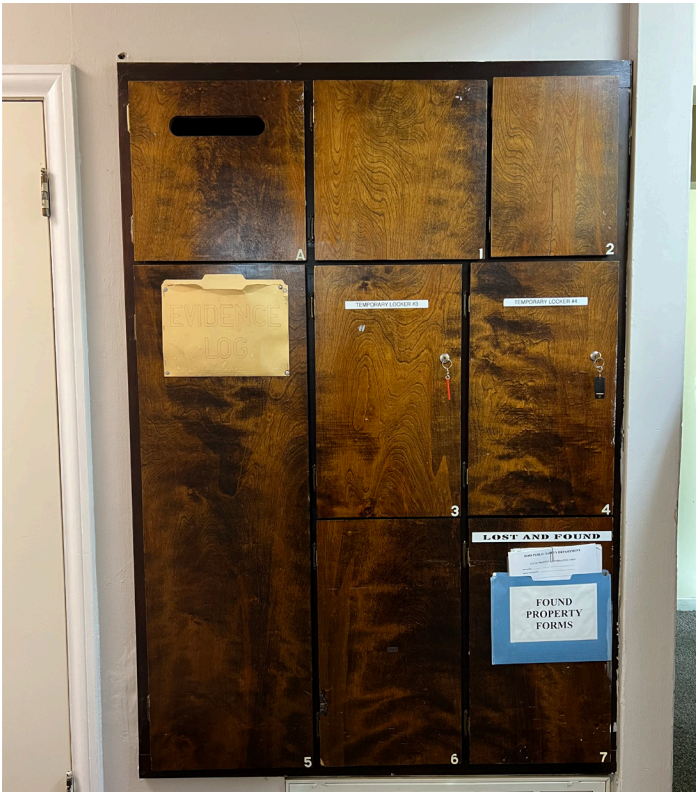
Police Station - Evidence Locker

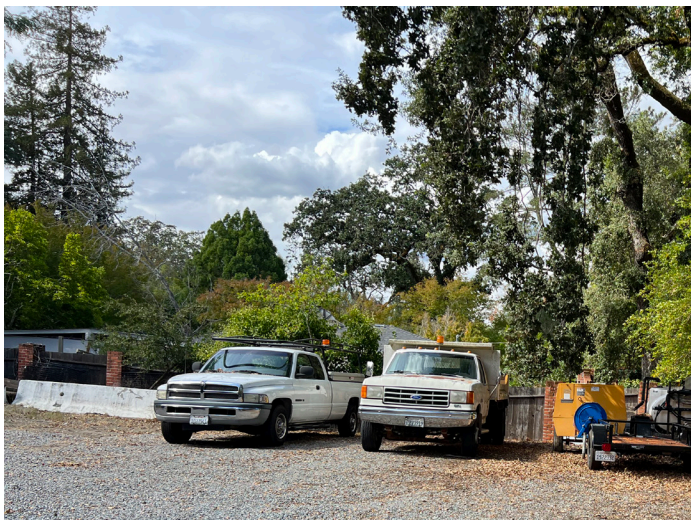
Public Works - Additional Maintenance Vehicles
